In 2008 John Sumner used our Builder Assistance Program to build his brand new A600 TALON. John's Talon was one of the first to be built in Australia, and draws admiring comments from all who see it.

Building the Talon

John Sumner

Part 1

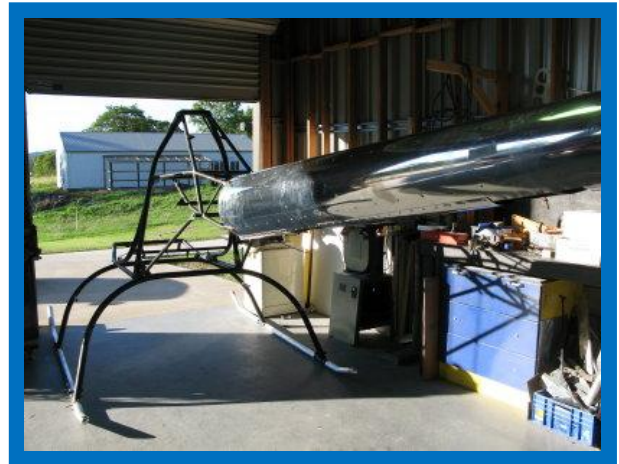
The panels are held together with "cleco" bolts; an expanding split pin that just holds things in place until you take it apart again. You get used to using a lot of these! We had also sent the skids to a motor bike shop to be polished. They came back just like chrome.
